Community Irrigation Committee - Rocky Mansfield, Chair

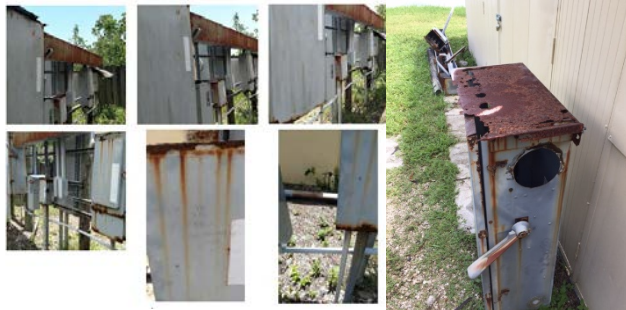
Before Pictures

During the assessment period, the committee discovered only one pump was fully functioning out of the three. Pump three had a bad check valve on the intake causing it to pump water back into the pond. The controller for pump one did not work. While pump two was

functioning, it was obvious the bearings were going bad from overuse. The noise from the bearings inside the building was louder than at a rock concert. Even simple items such as the building lighting did not work, and the electrical panels were rusted through and not up to code as seen in the before pictures on the left. Below are the after pictures.

The committee is happy to be able to say that all the items have been repaired/replaced as needed from within the irrigation committee's operations budget. The pump house is now functioning as intended delivering water as needed to the community.
